# Analysis of the decompression state of a landslide side in urban environment.

**ABSTRACT:** the execution of the geological researches pertinent to the reorganization and the reinforcement of a public building called Villa Immacolata, pointed out the existence of a complex system of subsurface fracturing in line with the morphology of the neighbouring polygenic scarp. The subsequent geophysical inquiries allowed to map such fractures up to a depth of about 30 m, enough to cause the breaking of the foundation grade beams with horizontal displacements of 4 centimetres. Finally the result of the geotechnic analyses, which required numerical models with finite elements, brought to advise against the restoration interventions of the building, element totally non applied by the contracting station. After three years from the end of the works the building is damaged again.

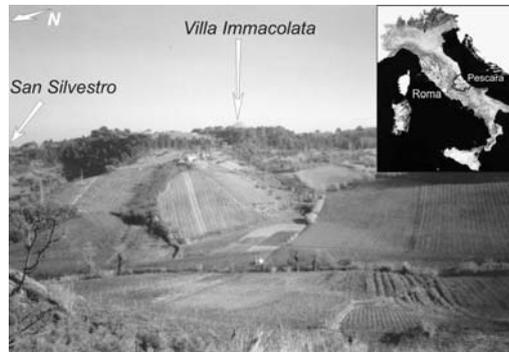
Figure 1. Territorial scheme

In searching the reasons which had produced the damaging of a public building of multi-floor, called Villa Immacolata (Figure 1), object of reorganization and reinforcement for the Jubilee of 2000 and situated in San Silvestro (Pescara - Italy), from the beginning the existence of a system of subsurface fracturing, which had determined the growth of plastic hinges to the structural nodes of the first floor system and of a diffuse fissured picture, has been clear. A series of morphologic steps corresponded to such fracturing on the topographic surface, represented by a densely urbanized morphologic level and connected to the valley floor through a largely deformed side.

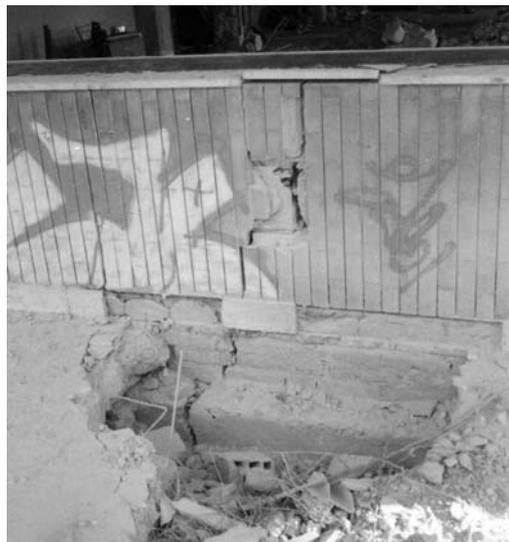
Figure 2. Crack passing on foundation of grade beams, with a horizontal translation of 4 cm.

The researches carried out on the complex soil-structure showed the existence of a tension field of prevalent traction and cut-off, with zones affected by a pure traction able to produce cracks on a portion of the grade beam foundation and associated horizontal displacements of 4 cm (fig. 2), to

which supplementary moments of 78 kNm that act on the foundations-pillars nodes and pillars-beams of the 1° floor system correspond.

Since the geotechnic analyses have been used with predictive purposes, it is necessary to compare the obtained results to the initial data: the fracture of the foundation grade beams with horizontal displacement of 4 cm, distributed in the 35 years from the date of the building (ca 1965) to the date of the analyses execution (2000). Therefore the medium rate of the reference translation is of 1,14 mm/year.

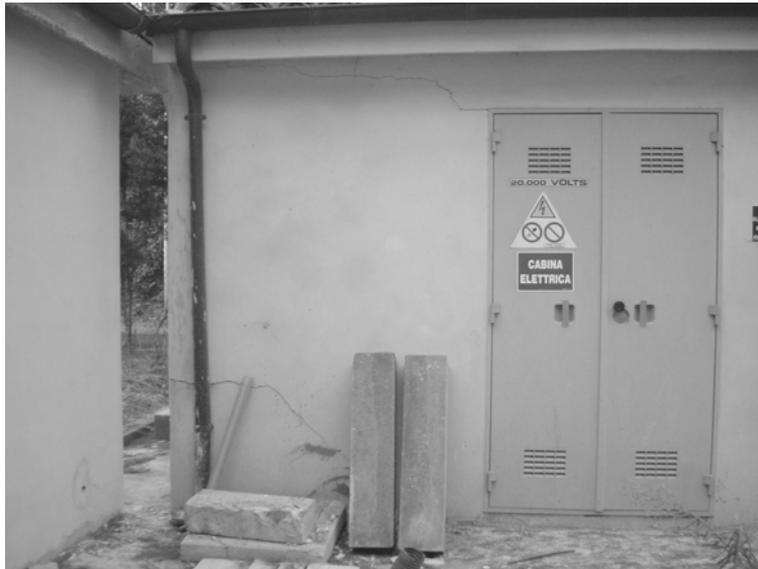
Figure 6. Cracks for a flexion cut-off combined action of a new handwork used as an electric cab, next to the principal building.

In other words, the geotechnique analyses, as final step of a wider multidisciplinary research, advised against the restoration interventions of the building which was absolutely not applied by the contracting station and the planners. After three years from the end of the works, the building is cracked again; it shows a cracks in line with the orientation of the subsurface fracturing system. Moreover, as Figure 6 shows, the state of the site decompression is such as to produce the appearance and widening of cracks also on new building built in the last three-years period.

planners to adopt technical expedients in order to safeguard the static integrity and the future functionality of the building, such as carrying out jet-grouting pushed to the depth of 30 metres. Since the existence of an organized system of fracturation of the surface, responsible of the side decompression phenomena was difficult to perceive for the planners, they chose to adopt the subfoundations micropales 9 m long, incapable in our opinion, to offer the right degree of safety to the building, to renovate and consolidate.
